Home Appeal Inspections, LLC

Confidential - Property Inspection Report - Confidential

123 Old House BLVD, AI
Inspection prepared for: Old House Example
Date of Inspection: 11/30/2020
Age of Home: 1920 Size: 2820

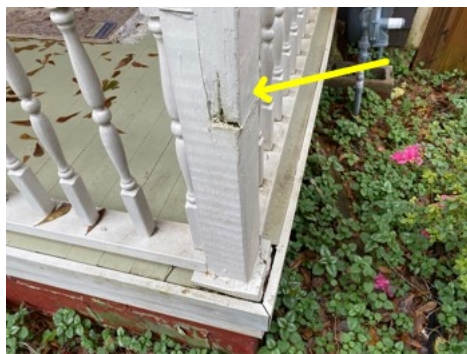
- Inspected
- A wood post at the front porch shows indications of wood decay at the bottom portions, repair or replace as needed then recommend installing the post on an aluminum or other approved stand-off to prevent water from wicking up into the wood, then secure as needed.

Wood decay at bottom of post-Front

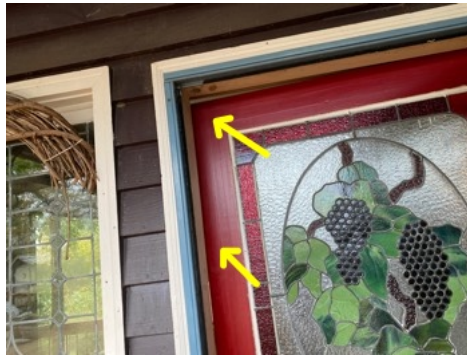
- Inspected
- The front door is binding at the frame. Recommend a licensed general contractor to repair as needed.

Door jam binding

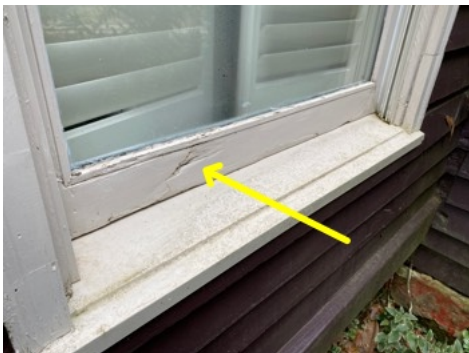
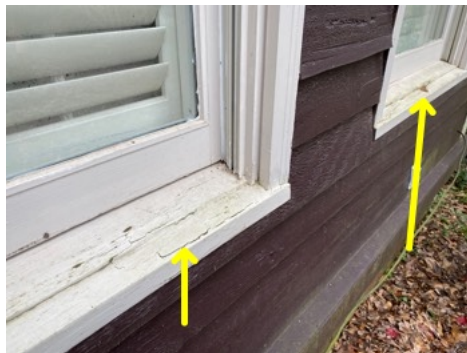
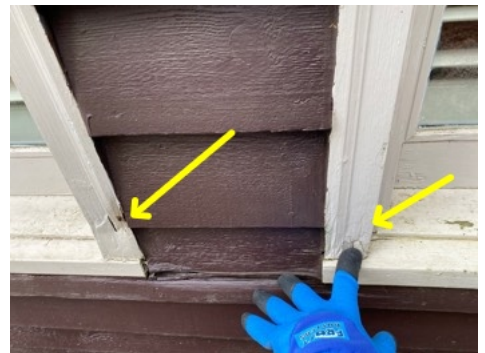
- The paint around the window casings is peeling/cracking at North, West windows of the home. Although heavy paint cracking is not observed, Recommend routine prep, prime and painting with a quality exterior paint. This action is to prevent further weathering of the surface.
- Repair or Replace: Wood decay was observed on the west window frame.
- The trim at the bottom portion of the wood windows is weathered at various places. Recommend a licensed general contractor to repair the affected areas.

Wood decay at door frame-West Weathered wood-Window frames Weathered window trim-West

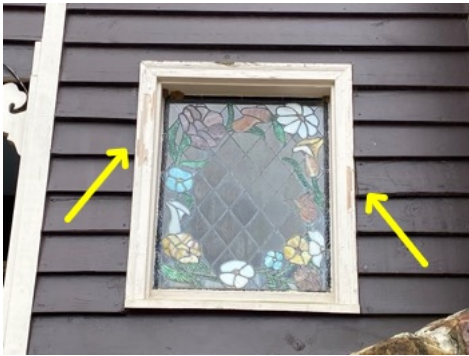
Peeling paint-North

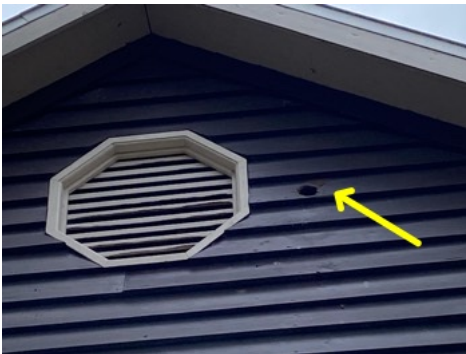
- An apparent wildlife hole was observed at the south gable. Recommend ceiling this access point as needed.
- Repair or Replace: A small portion of siding on the west side of the home between two windows has indications of wood decay.

Wildlife hole-South

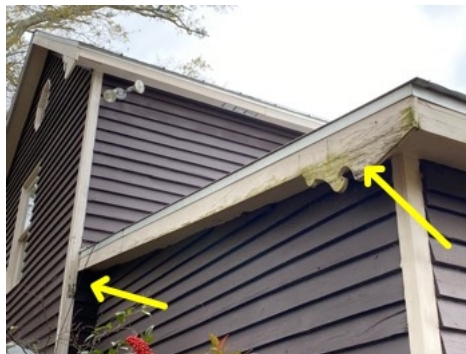
- Peeling paint observed on the fascia at the rear and sides, prep and paint as needed.

Flaking paint at fascia

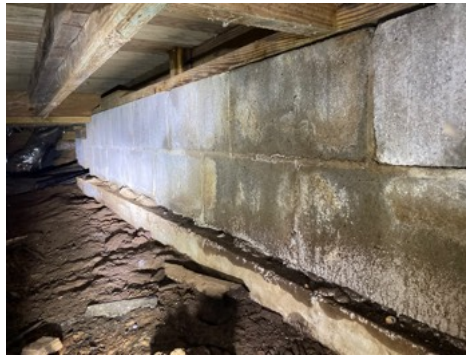
- Inspected at visible areas
- The masonry foundation walls appear to be in adequate condition with some indications of water intrusion/staining along the bottom masonry block line. Suspect water from poor exterior drainage.

Foundation wall view

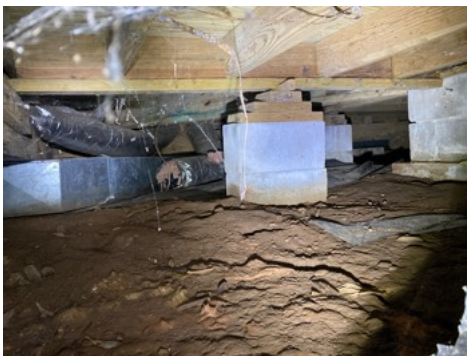
- The vapor barrier in the crawlspace is not present for full coverage. The vapor barrier is important because the barrier limits the amount of moisture that can evaporate out of the soil into the crawlspace. High humidity can result in mold and accelerated wood deterioration. Recommend installing a vapor barrier as needed for total coverage.

Missing vapor barrier

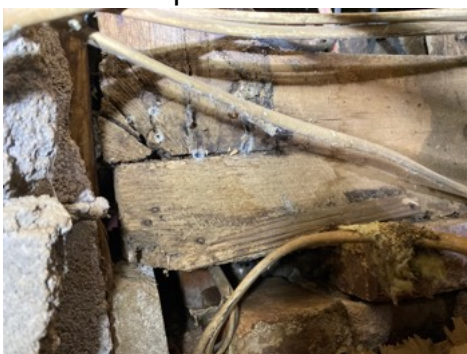
Past staining- Under laundry room

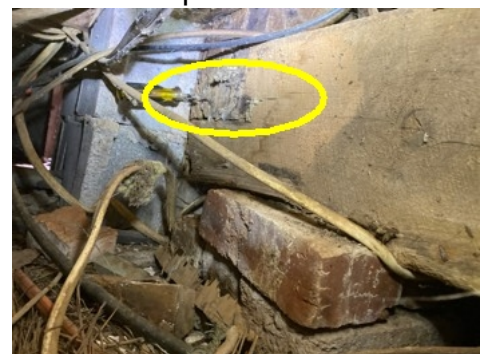
Past water leakage under laundry room area

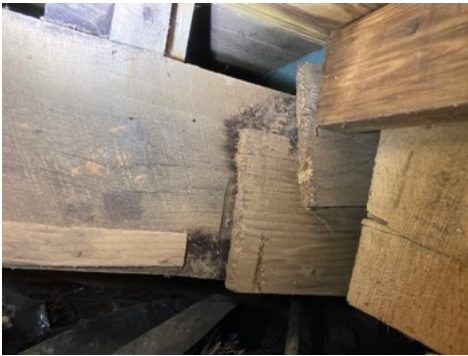
Past repairs

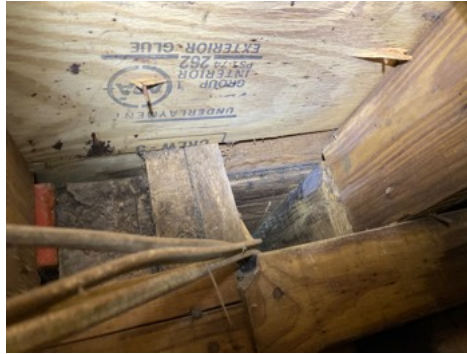
Past repairs under laundry room area.

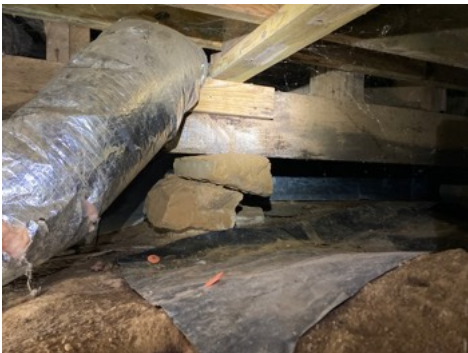
- Improve: Floor support piers constructed of stone, masonry blocks and brick was observed inside the crawlspace. It appears that post-construction pier and beam support improvements have been performed. These supports are adequately installed and stable, but it is noted that a footer or 16" x 16" pier pads did not appear to be installed under the post-construction piers when probed. The addition of the pads will prevent eventual settling of these piers over time.

Pier view

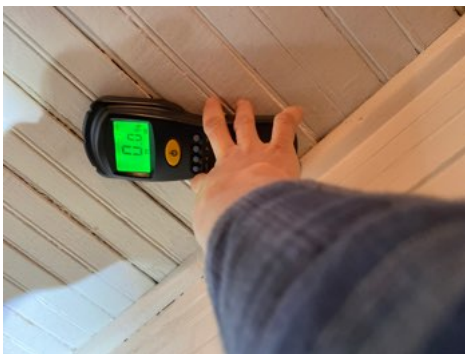
Past staining- ambient moisture reading- den West wall

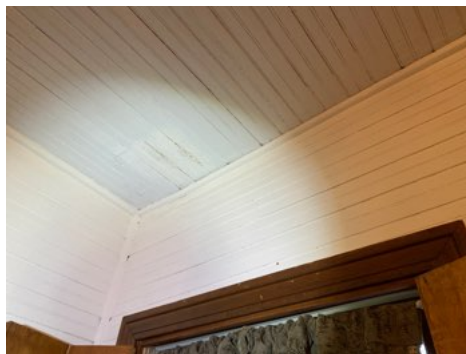
Past staining- ceiling of west wall- den

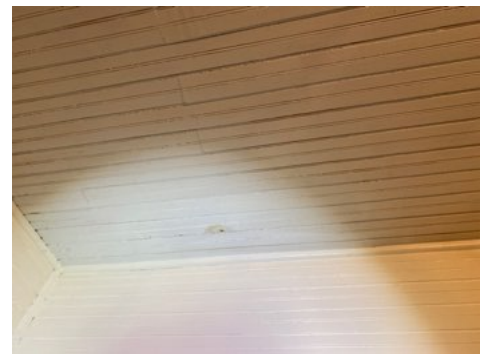
Past Moisture staining- den ceiling- north wall

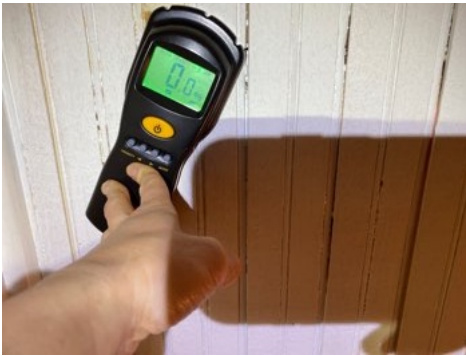
Ambient Moisture reading on past staining- den ceiling- north wall

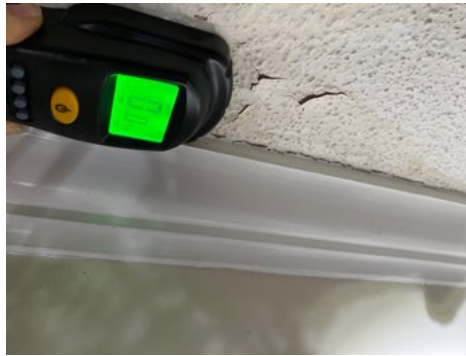
Ambient moisture reading- flaking ceiling texture over upstairs bathroom sink

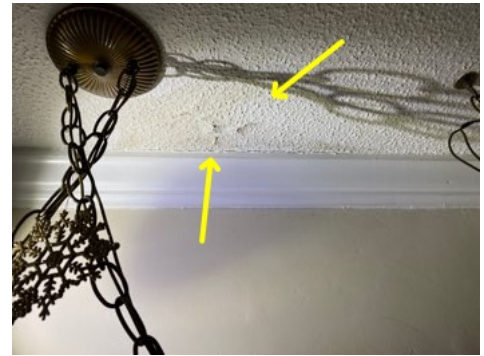
Ceiling texture flaking- upstairs bathroom

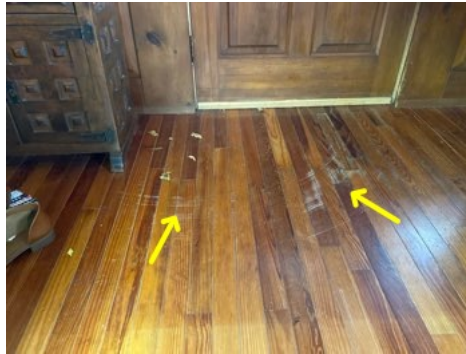
Floor scratches by back (NW) door

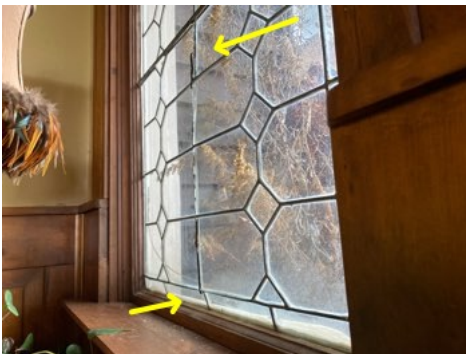
- The leaded glass window by the back door on the Northwest side of the home has bowed and cracked lead in multiple places in the lower third of the window. Repair as needed.
- Flaking paint and some wood decay was observed on the window sashes and casing for most windows. The windows would not open with expected effort as well. Recommend a qualified licensed contractor to review the windows and determine if repair is an option or if replacement is necessary.

Cracked pane, broken/bowed lead, window by back (NW) door

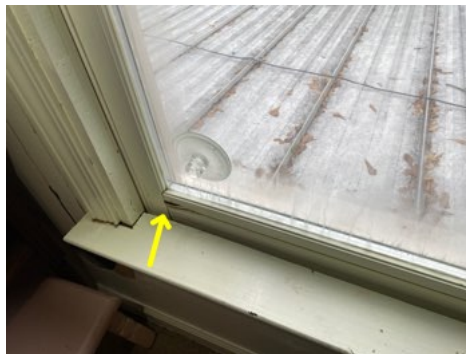
Deteriorated window sash- upstairs bedroom2 East wall

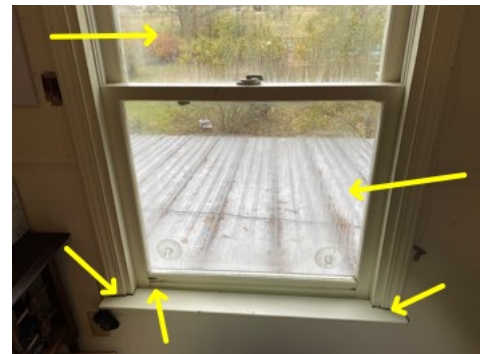
Condensation, deteriorated window sash, deteriorated windowsill- upstairs bedroom East wall

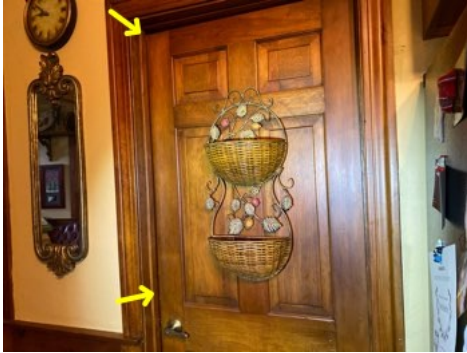
Door rubs frame-
bathroom/laundry room

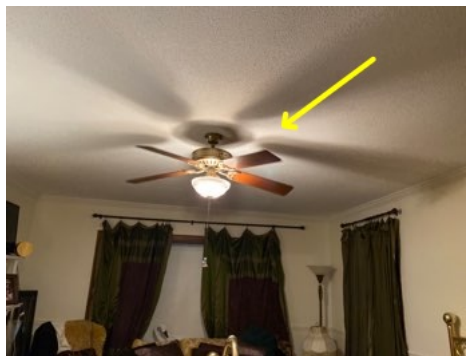
- Inspected
- Unbalanced fan in the SEmaster bedroom , repair or replace as needed.

Unbalanced fan- master bedroom

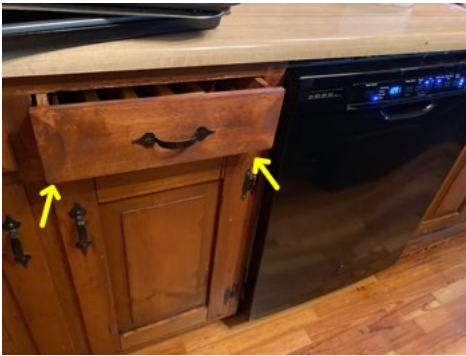
Drawer to left of dishwasher does not slide freely

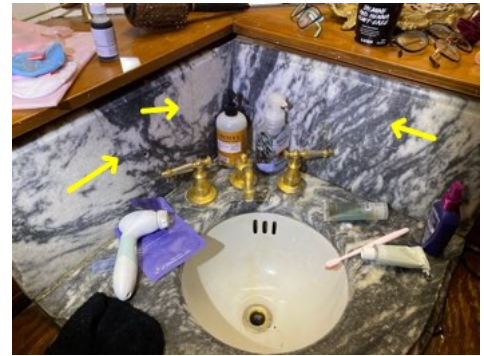
Cracks in master vanity backsplash

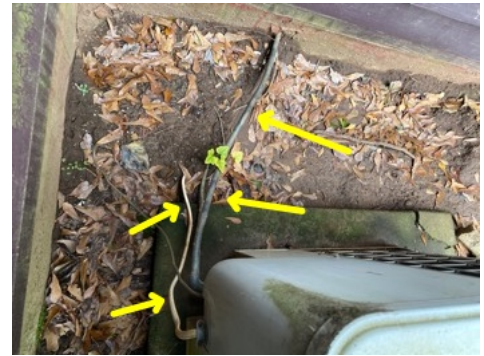
Suction line insulation is missing and weathered.

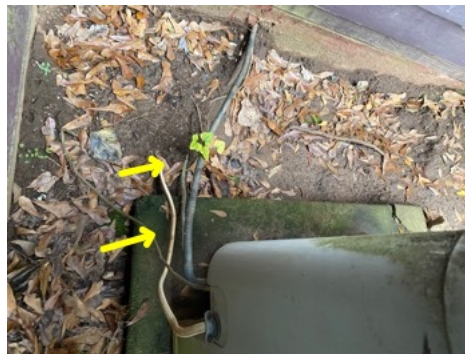
- The wiring for the condenser is not installed in conduit. A qualified licensed general contractor is recommended to install this wiring inside conduit.

HVAC wiring not in conduit

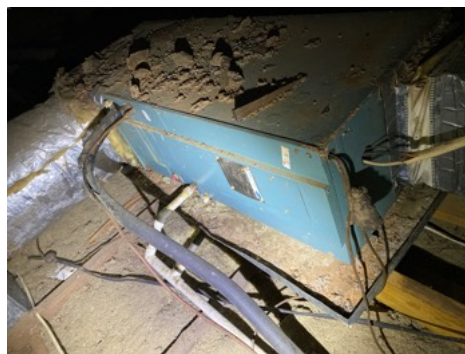
- The air handler in the attic does not appear to be in working order. A licensed HVAC technician is recommended to review the complete system, including duct work and register connections and advise for repair.

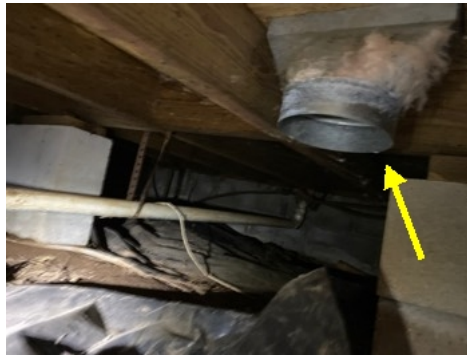
- Registers without duct work attached was observed in the crawlspace, correction is recommended when the system are repaired.

Registers without ducting attached

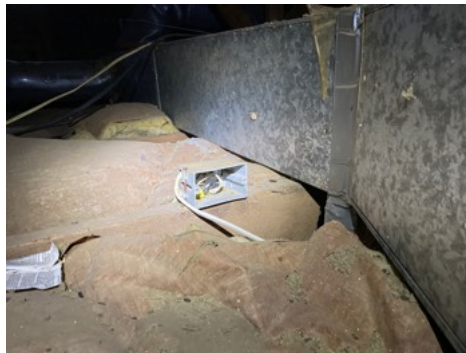
- Uncovered junction boxes noted in the attic. Cover as needed at the affected locations.

No cover on J-box in attic

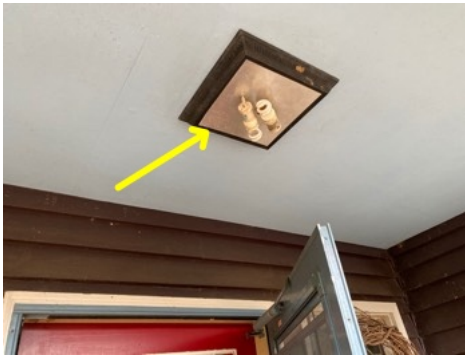
No globe-Porch

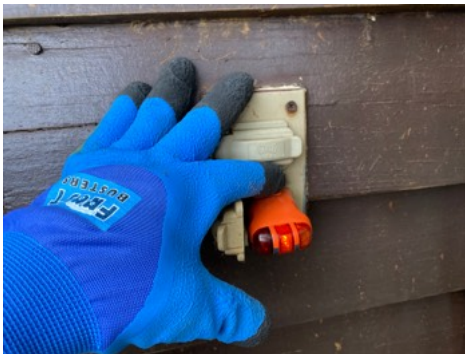
- There is not GFCI protection in all required areas. Although GFI protection may not have been installed at the time of construction, it is recommended to update with this protection device at locations in kitchen within 6 feet of the sink, bath rooms, and exterior. Recommend a qualified electrician to install as needed.

NO GFCI at exterior

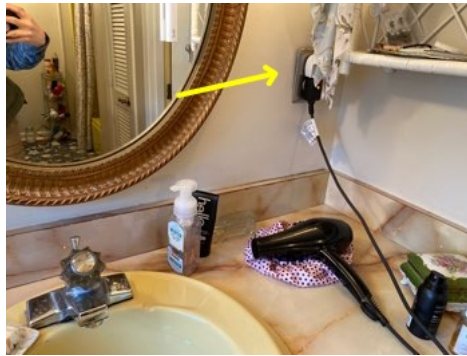
No GFCI in upstairs bathroom

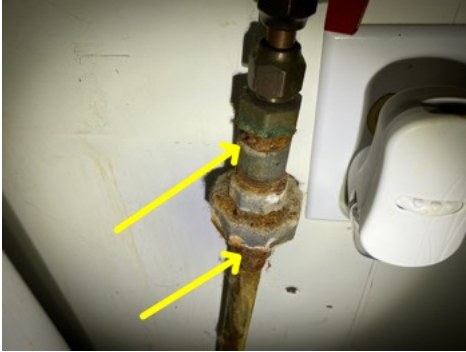
Rust and corrosion on water heater supply piping

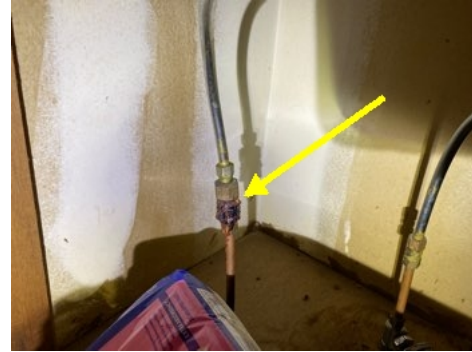
- Corrosion observed on the master bathroom sink supply line. Recommend a qualified contractor to clean corrosion and advise on condition.
- Rust and corrosion was observed on the water heater supply piping. Recommend a licensed plumber to clean the affected areas to ensure reliability.

Corroded supply valve- master bath sink

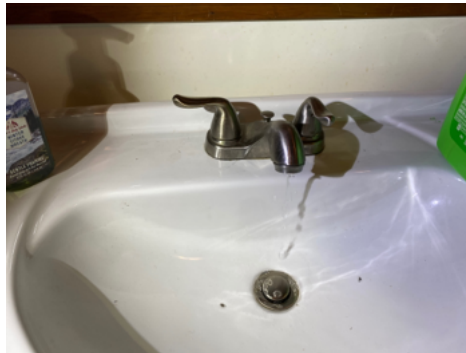
- Inspected
- The sink in the laundry room was observed to have a very low flow, even when the faucet handles were turned completely open. Recommend a licensed plumber to review and repair as needed.

Poor/low flow- laundry room/bathroom sink

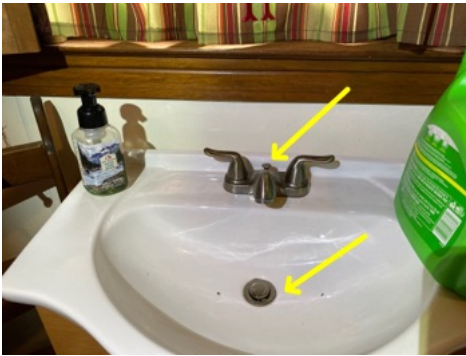
Inoperable sink stopper in bathroom/laundry room sink

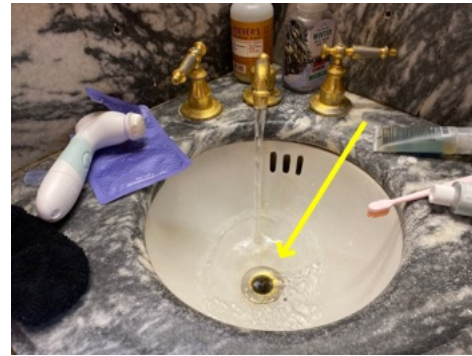
Missing stopper Master bathroom sink

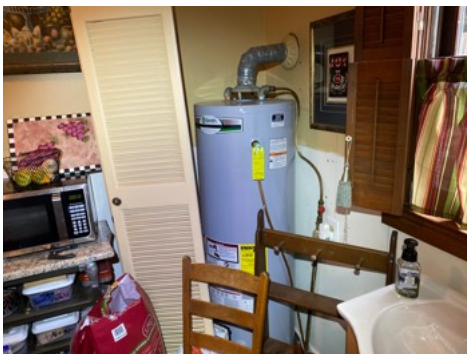
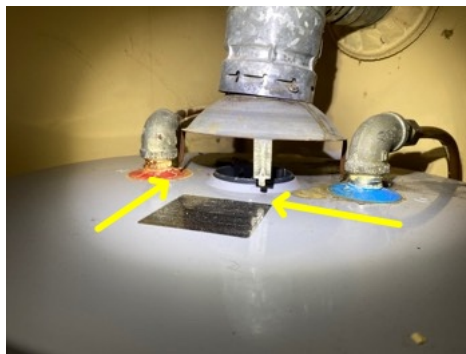
- Inspected
- The TPRV drain is plumbed with half inch copper tubing. Three-quarter inch piping is recommended for this application.
- Safety concern: the water heater hood vent is not properly centered and secured on top of the appliance. This condition may allow harmful gases into the interior of the home. Recommend repair by a licensed plumbing contractor.
- Water temperature is above 110 degrees-135°. It is recommended to set the water temperature at 110 degrees to prevent scalding. Recommend lowering the setting to this temperature for safety reasons.

Vent hood not centered and positioned on appliance
