Home Appeal Inspections, LLC

Confidential - Property Inspection Report - Confidential

123 Old House BLVD, AI
Inspection prepared for: Old House Example
Date of Inspection: 11/30/2020
Age of Home: 1920 Size: 2820

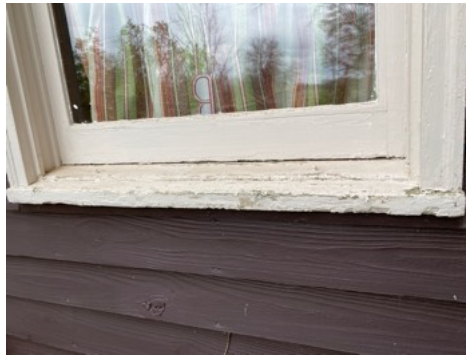
Weathered wood-East

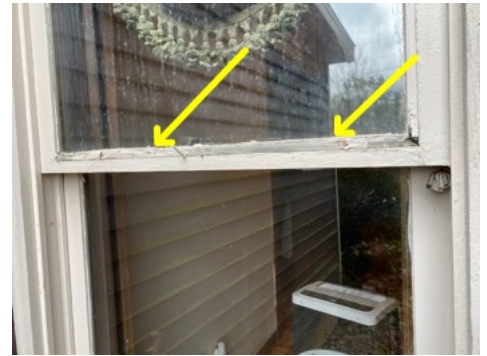
Weathered wood-East

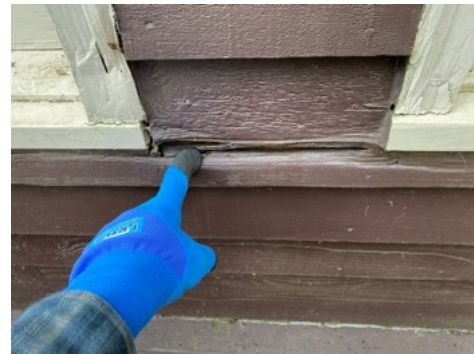
Weathered wood-West

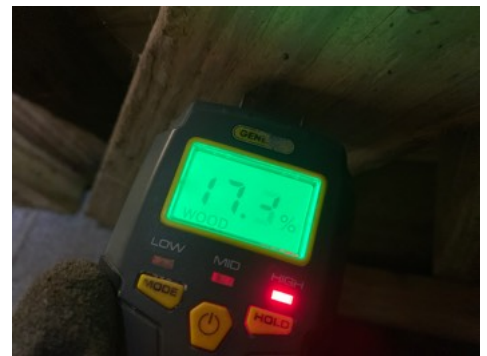
Wood humidity-S

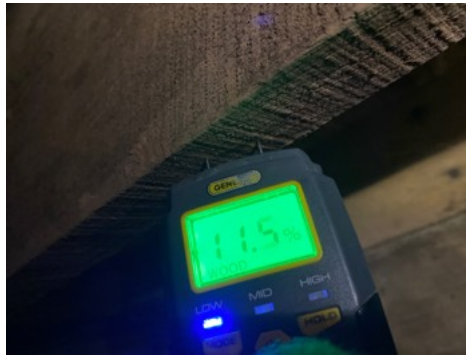
Wood Humidity-E

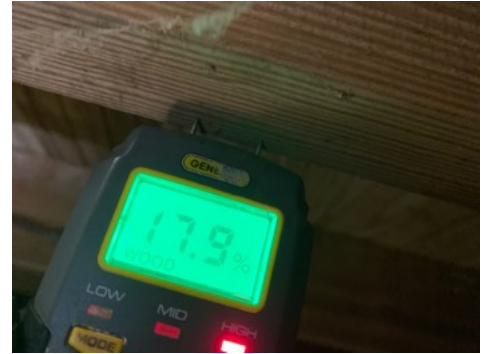
Wood Humidity-W

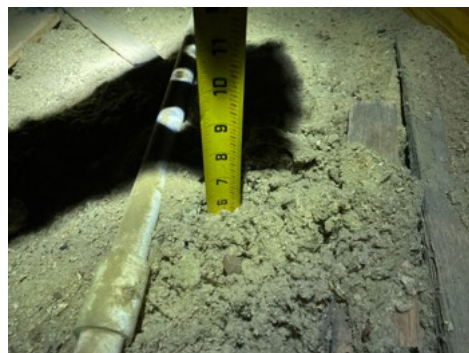
Random measurements of insulation

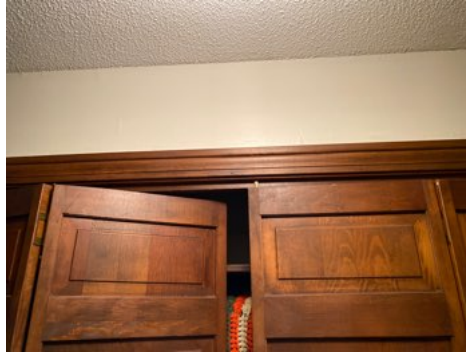
Bi-fold doors off track- master
closet

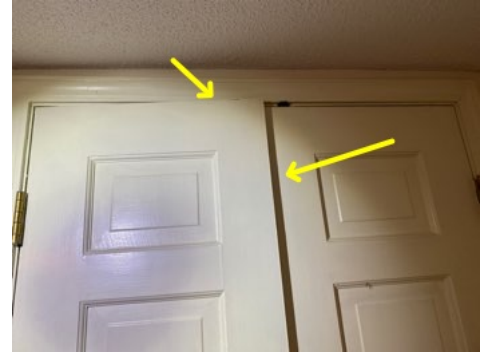
Door rubs on other door- upstairs
bedroom2 closet

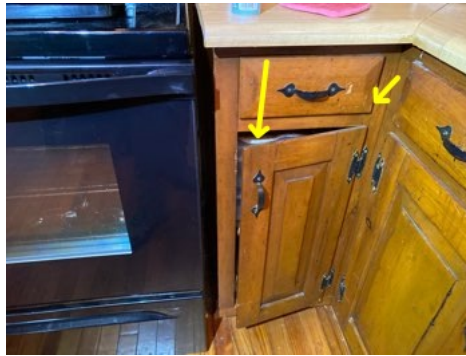
Cabinet door does not stay closed- right of stove

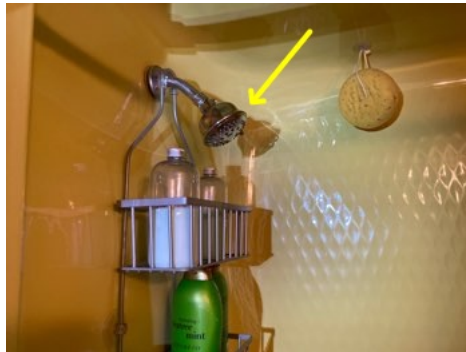
- Inspected
- Note: the upstairs shower drips when turned off

Shower head dripping- upstairs bathroom

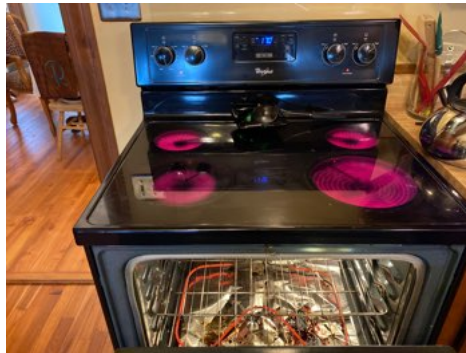
Range heat element view

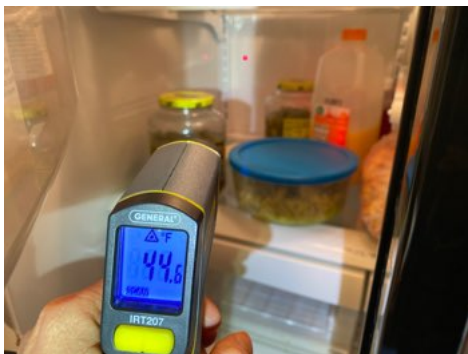
Cooling temp- refrigerator

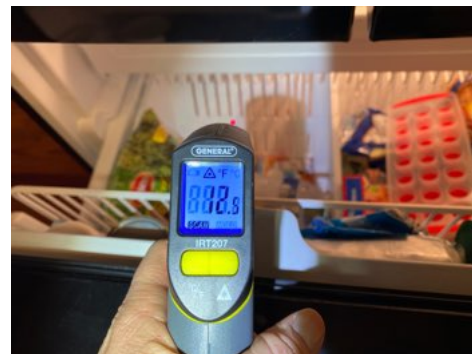
Cooling temp- freezer

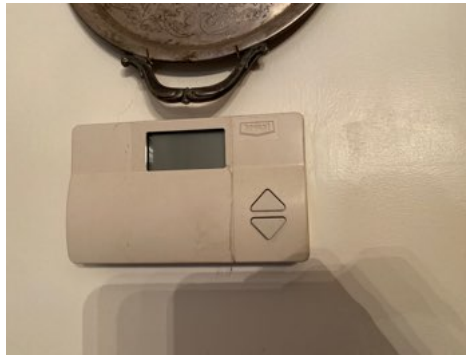
- Power was not supplied to the thermostats.

Thermostat off- downstairs

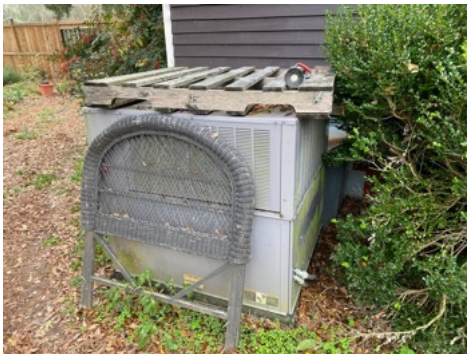
- Repair or Replace: The conduit connected to the package unit is unsecured.
- The packaged HVAC unit was not tested. A pallet was stacked on top of the unit and the unit did not appear to be in working order. A licensed HVAC technician is recommended to review the complete system, including duct work and register connections and advise for repair.

Packaged unit view

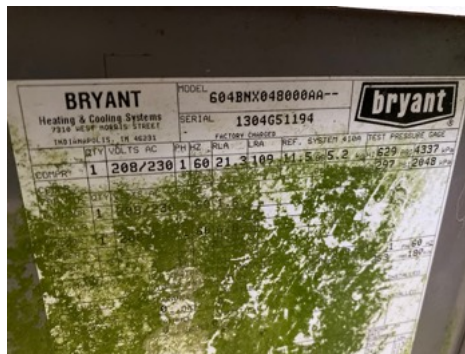
Data tag-2004-4ton

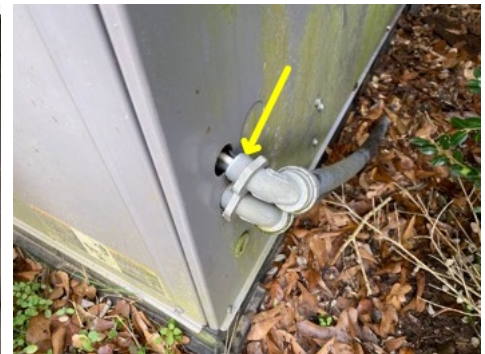
Unsecured connectors

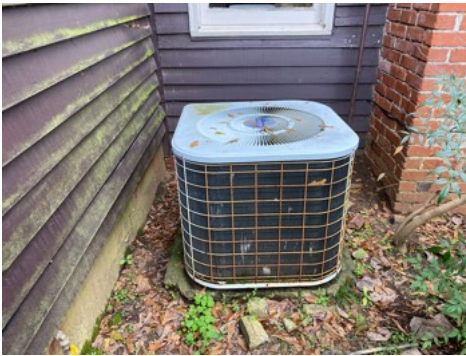
- The condenser did not appear to be in working order, the HVAC system appears to be a 1993 model. Typical life span of a heat pump system/AC system is 12-15 years with proper service intervals. Recommend a qualified HVAC technician to review the unit and advise for reliability. In addition, recommend maintaining a home warranty policy to assist in the event of unexpected failure.
- Insulation on suction line is missing. Replace as needed to assist in efficiency of the unit.

Condenser view

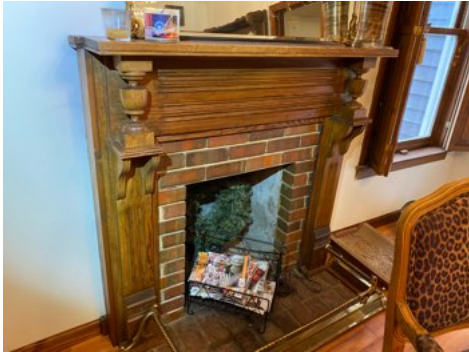
Decommissioned wood burning fireplace- dining room

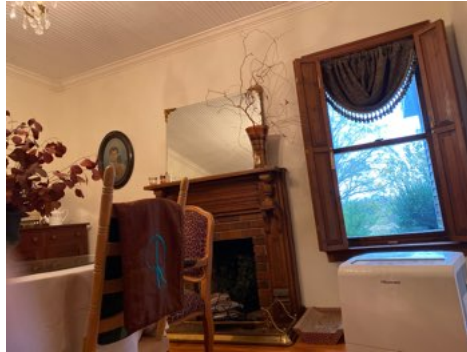
Interior chimney view- No staining- dining room

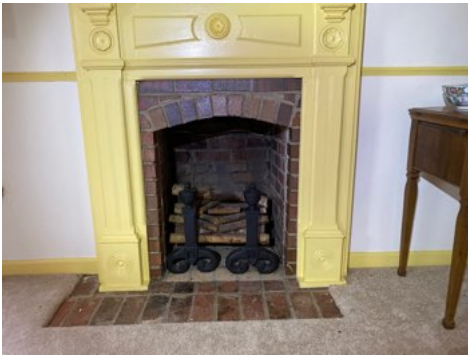
- Insulation was observed when looking up the chimney in upstairs bedroom1
- Note: The captioned pictures identify the condition of the fireplaces.

Decommissioned wood burning fireplace with unplugged electric logs-upstairs bedroom1

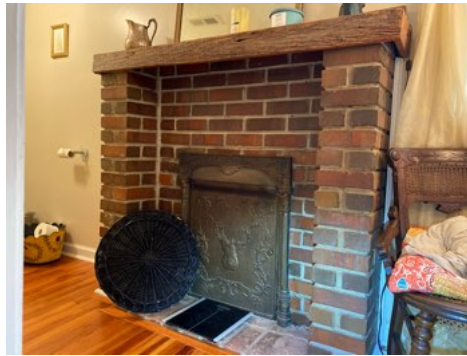
Decommissioned wood burning fireplace- upstairs bathroom

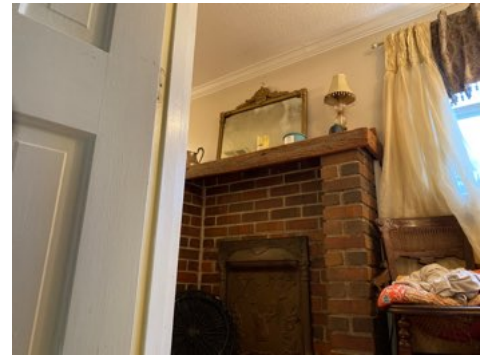
Interior chimney view- No staining- upstairs bathroom

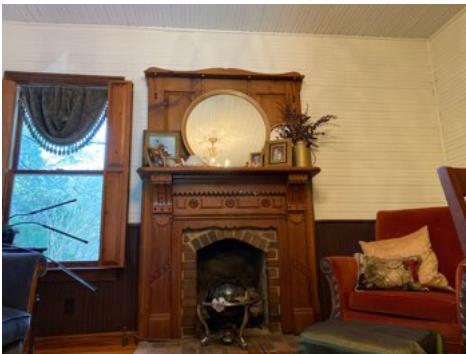
- The wood-burning Fireplace in the den is equipped with gas logs, which are turned off at the valve. Due to the presence of cobwebs, and personal items the gas logs were not tested. Additionally while the chimney appears open, it also appears to have collapsed brick inside it, and the safety of operating is questionable.

Interior chimney view- No staining- den

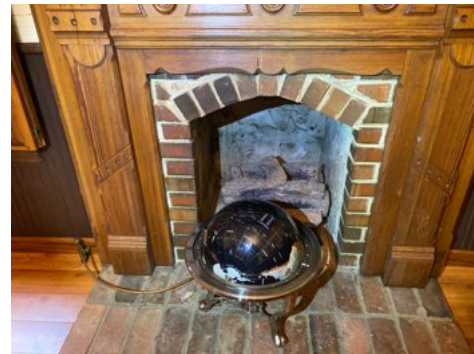
Gas valve in off position- gas logs not tested- den

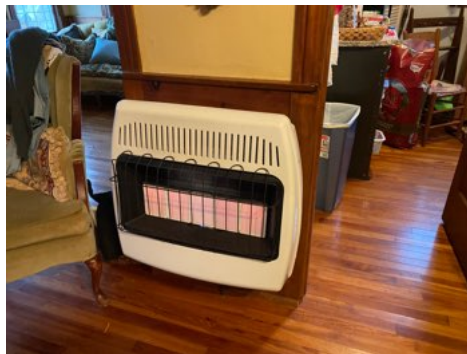
Wall heater functional- kitchen

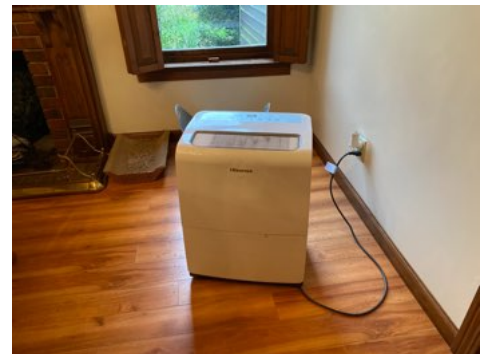
100 pint dehumidifier- dining room

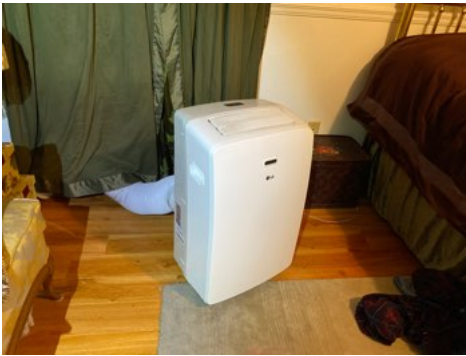
Portable AC unit- master bedroom

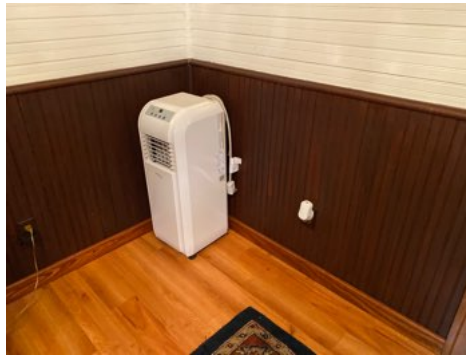
Portable AC unit- den

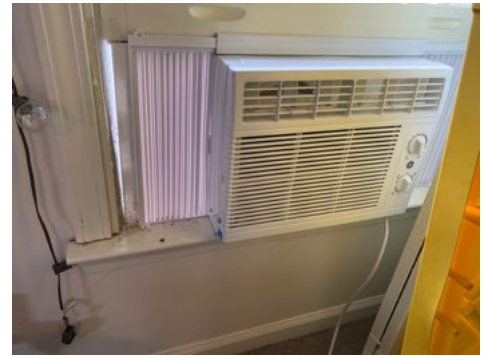
Window AC unit- upstairs bedroom2

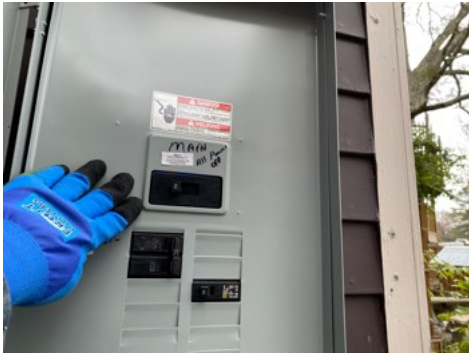
Main breaker at meter

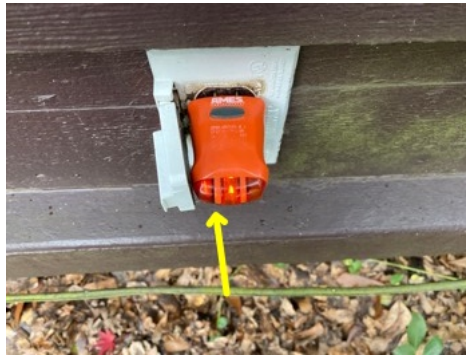
- Reverse polarity receptacles observed on the north west exterior of the home. Recommend repair by a licensed electrician.
- Reverse polarity observed in the sunroom, a reversed condition is when the "hot" and "neutral" wires are reversed on the receptacle. Recommend a qualified electrician to correct as needed.
- Open Grounded outlet observed in the dining room. Grounded plugs provide an extra level of safety by grounding the metal housing of the device. Recommend a licensed electrician to repair any open grounded outlets.

Reverse polarity-NW exterior

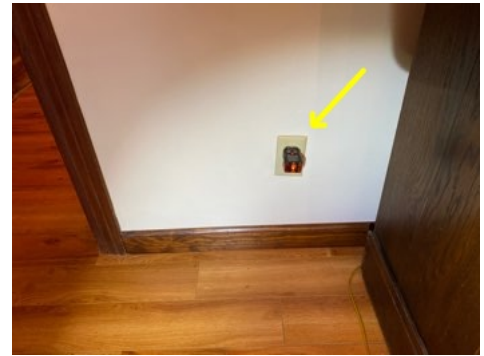
Open ground- dining room West wall

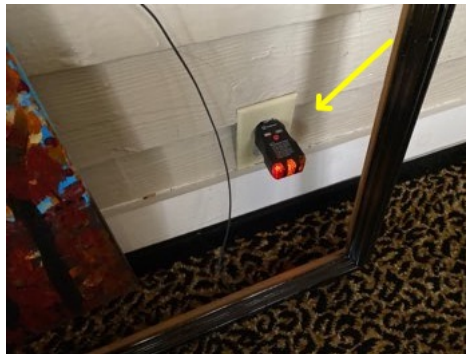
Reverse polarity- sun porch east wall

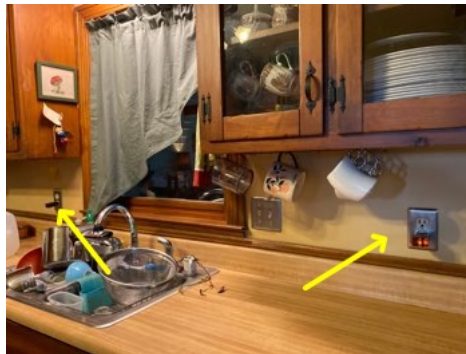
- GFI protection was not observed in all the required areas of the home by modern standards
- Not installed in Kitchen
- Not installed at all bathrooms
- Not installed at all exterior locations

No GFCIs- kitchen

- There is not GFCI protection in all required areas. Although GFI protection may not have been installed at the time of construction, it is recommended to update with this protection device at locations in kitchen within 6 feet of the sink, bath rooms, and exterior. Recommend a qualified electrician to install as needed.

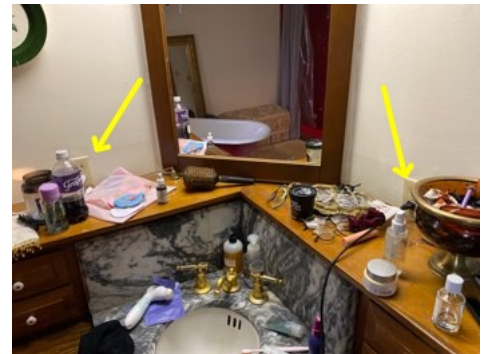
No GFCI in master bathroom

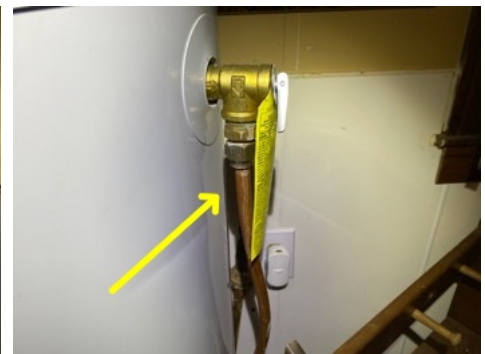
Reduced to 1/2"

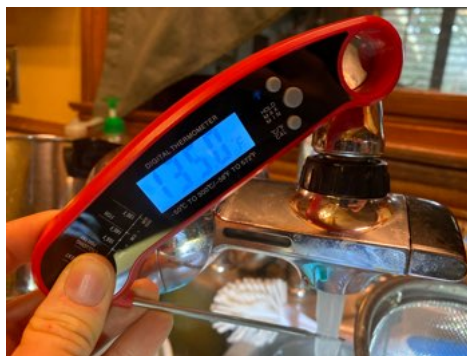
Water heater Temp
